21 ARDEN STREET, NEW YORK

- Project:** Fifteen (15) Multi-Family Residential Units at 21 Arden Street, New York, NY
- Description:** A Substantial (Gut) Rehabilitation of a 5-story and a Cellar level Multi-Family building with fifteen (15) Residential Units.
- Features:** Six (6) One-Bedroom Units, Nine (9) Two-Bedroom Units and building storage and mechanical rooms in the cellar.
- Structural Innovation:** Solid 'Atlas' Clay Brick Masonry bear walls, wide flange steel columns and beams and light gage metal joists.
- Size:** 12,650 Square Feet Gross Area
- Completion:** Spring 2022
- Cost:** \$4,792,000.00 (Construction Hard Cost)

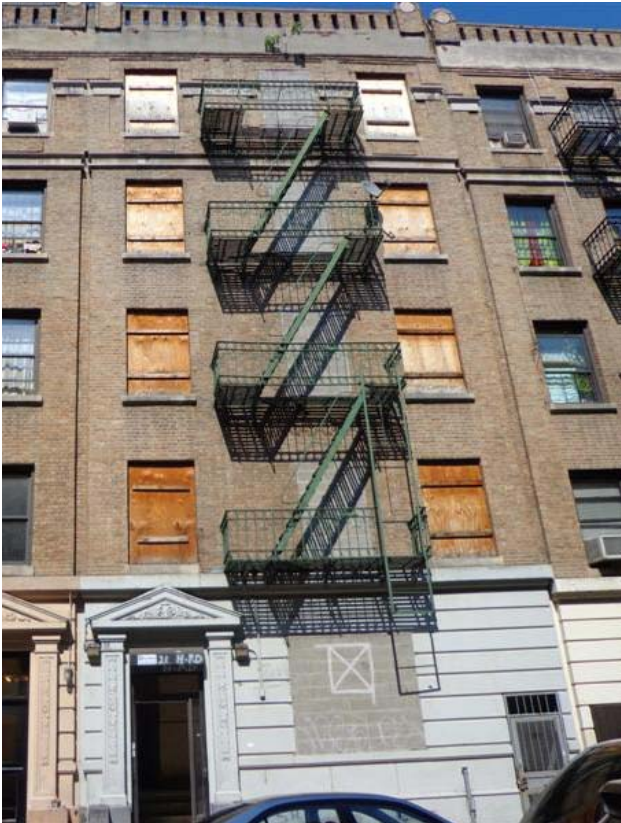
EXISTING BUILDING PRIOR TO RENOVATION

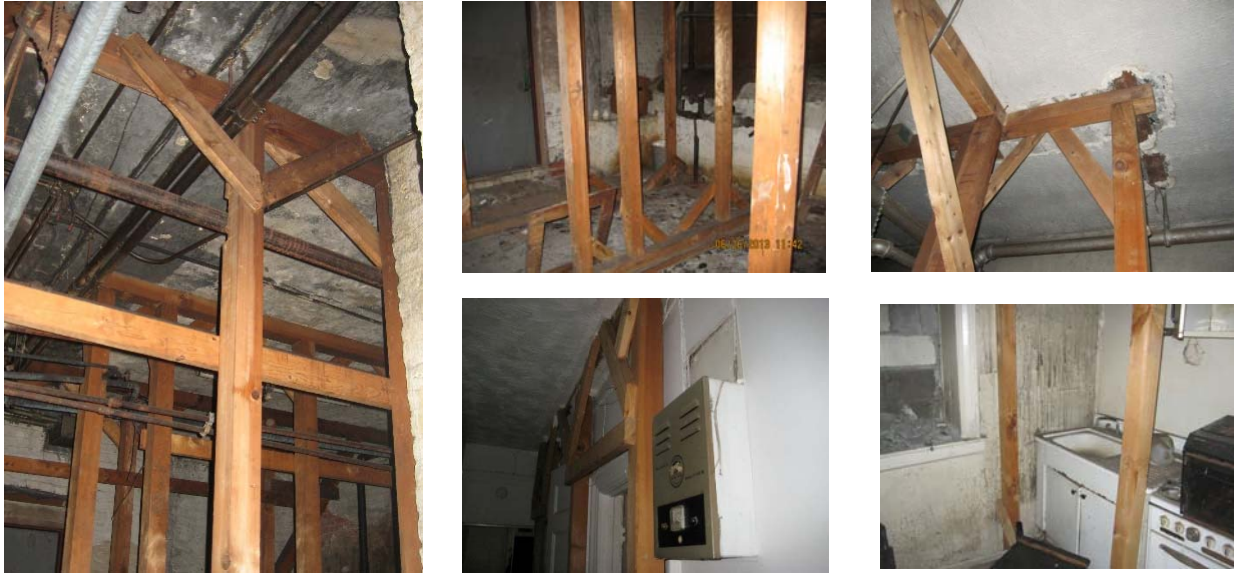
Temporary timber shoring supports were also installed at various locations on the all the floor levels. In addition, all of the floors from the second to the fifth floor appeared to be uneven and / or sloped.

Images of temporary timber supporting each floor

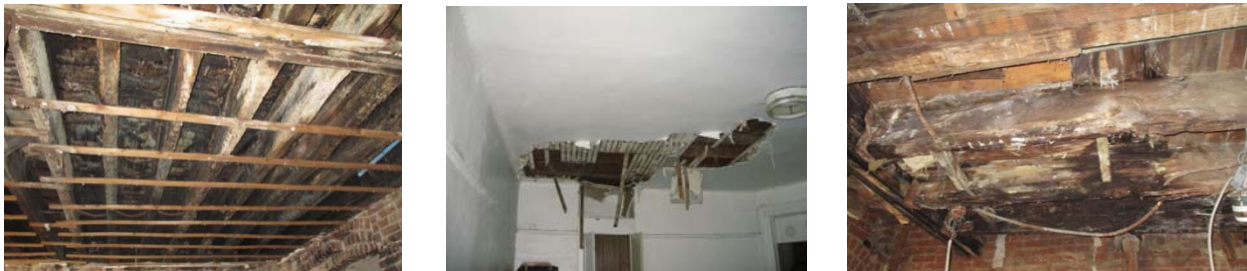
Portions of the ceiling below the lower floors and roof joist, had either fallen down due to active water damage from stemming from the deteriorated roof. In some areas where the joists were exposed, signs of a fire remained on the burnt floor joists. The wood framing underneath the existing bathroom areas were also heavily deteriorated. Cross bracing also fell away from the joist. Many of the existing wood floor joists in the kitchens and bathroom areas were either partially missing, damaged by the installation of plumbing fixtures, rotten or some combination of all three conditions.

Images of existing wood joist and ceiling heavily deteriorated and damaged

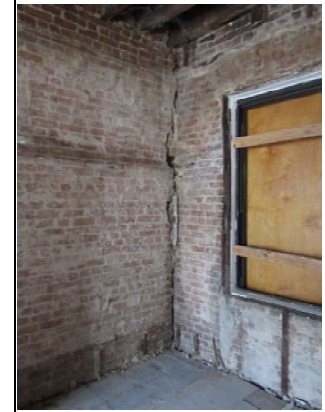
Once demolition commenced, the structural engineer determined that additional bracing and shoring was required in order to keep the building exterior walls intact and the construction workers safe. The demolition revealed that the outer exterior walls perpendicular to the party walls were in need of reinforcing.

Splaying of existing masonry wall at corner between party and outer exterior wall

Flatjack Measurement Test to determine the compressive strength of the existing brick masonry exterior walls and test pits to determine depth of existing footings and location of bedrock to accommodate new column footings. After the interior of the building was demolished, splaying of the existing brick masonry walls along the corners was observed causing additional concerns. Through wall $\frac{3}{4}$ " steel rod masonry ties with $\frac{1}{2}$ " steel plates were provide along the existing walls and tied back to the new steel structural framing to provide stability.

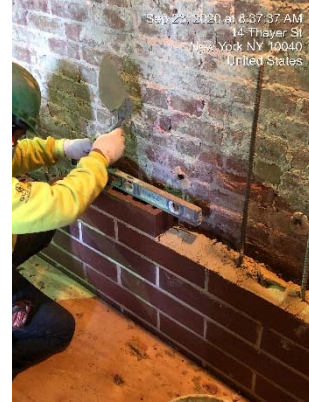
INSTALLATION OF STRUCTURAL ATLAS WALL

To eliminate the protrusion of new columns into the public hallway along the interior face of the north party wall, we designed an 8" secondary exposed 'Atlas' hollow clay structural brick wall by 'Interstate Brick'. This satisfied the structural challenges at this location and provided a beautiful finished brick wall surface in the pubic corridors and the east and west end apartments.

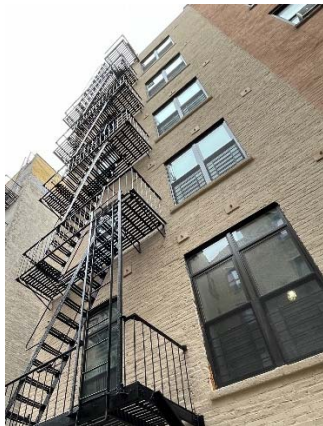
THROUGH ROD MASONRY TIES INSTALLED AT EXTERIOR WALL

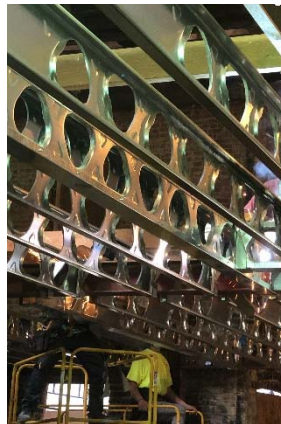
INSTALLATION OF JOISTRITE FLOOR JOISTS

The new framing system includes Marino/WaRE JoistRite metal joists, wide-flange steel beams and a few steel tube columns with interior bearing walls consisting of 3-5/8", 12 gauge studs @ 16"o.c. which were transferred onto beams and columns in the cellar floor.

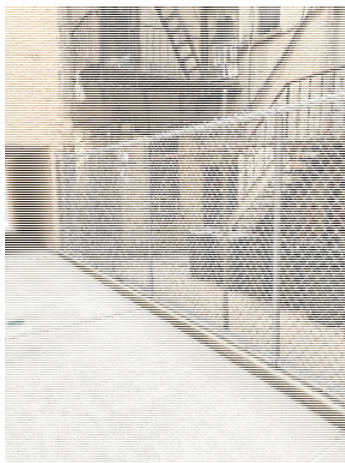
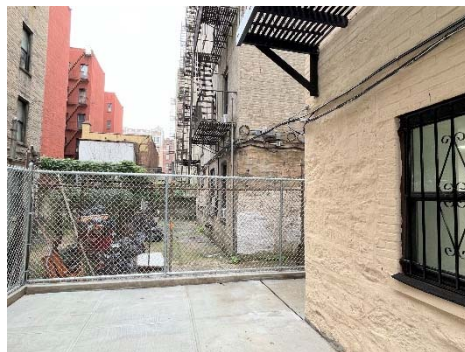
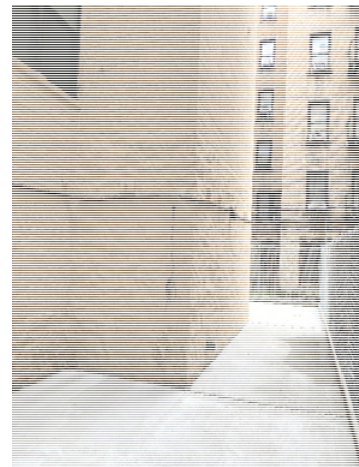
The floor of the existing uneven inner and rear courts was uneven and damaged throughout and had to be removed. A new concrete slab on grade was poured through out these courts rendering them pleasing and usable to the tenants.

New concrete slab on grade in inner court

New concrete slab on grade in inner yard
